Repairhints

Service-Level 3 & 4

3510 / 3510i

NHM-8

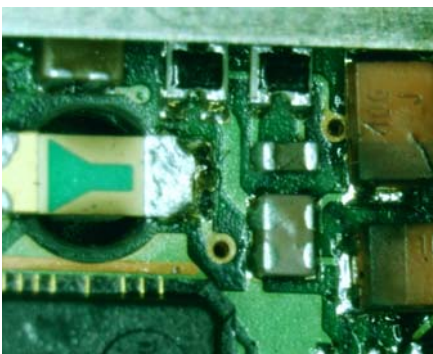
"rework" done with uncontrolled hot air

All replaceable (not underfilled) μ BGA components must be renewed after removing. Reflow with uncontrolled hot air fan is strictly forbidden! μ BGA must only be soldered with NMP approved μ BGA rework machines (e.g. Zevac / OK-Metcal / Martin) to get durable soldering joints.

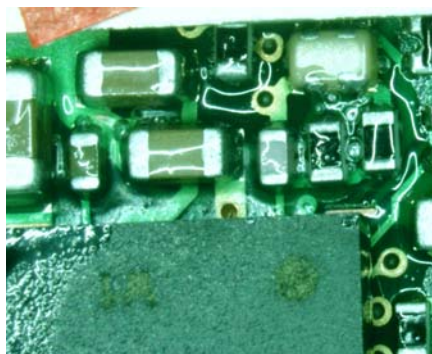
PCB drowned in flux

After removing a μ BGA check soldering points, if necessary rework oxidated solderings (broken balls) carefully by tinning these areas with few flux and a hot soldering iron. Before placing a new component remove the tin and clean the PCB, e.g. with help of solder wick and flux cleaner such as "Kontakt LR". Use only recommended Fluxtype and an appropriate amount of it – avoid drowning the PCB in flux as this will result in additional faults!

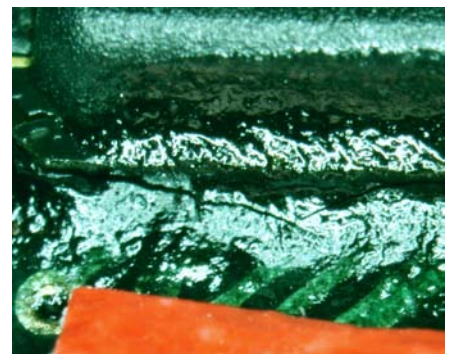
Also check underfilled parts for broken underfill material below. In this case carefully evaluate possible repair actions as the phone probably was exposed to strong mechanical stress.

broken underfill of an μ BGA part

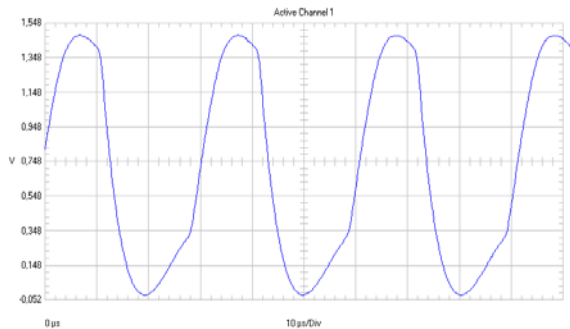
Figure 1: 32.768kHz at C209

- Check DC-voltages at C209 (0.59V) and C210 (0.42V). If voltages are not ok check lines for shorts to ground. It also is possible that UEM D200 is defect.
- Change the crystal B200 if DC-voltages at C209 / C210 are ok but no 32.768kHz sinewave signal is measurable (see picture below).
Note that this signal is always measurable in MJS-37 jig even though the phone is switched off.

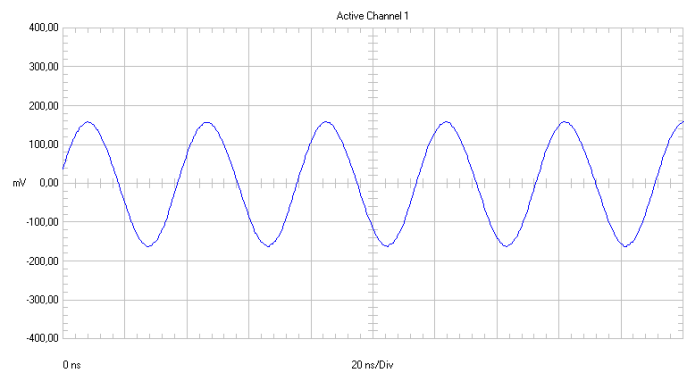
Figure 3: 26MHz at B600

- Check VR3 2.8VDC at C620.
- Check 26MHz sinewave signal at B600 (picture below). If it is not measurable check DC-voltage at both sides of crystal B600 that normally is 2VDC. In case that DC-voltage is missing Mjoelner N600 has to be changed. If voltage at crystal is ok but no 26MHz sinewave is measurable crystal B600 has to be exchanged.

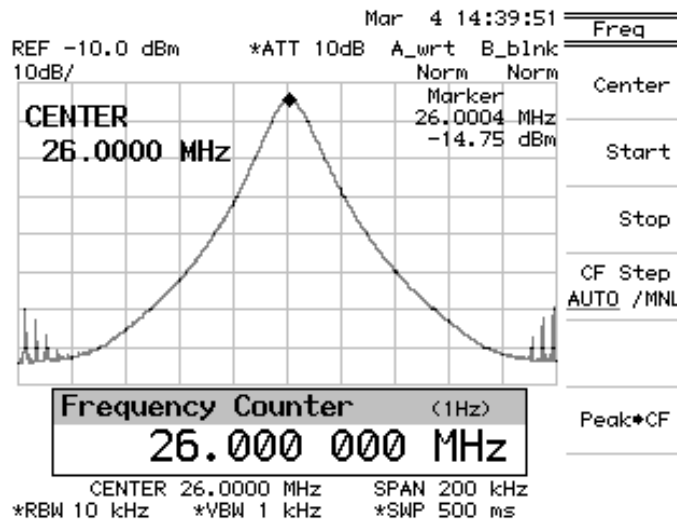
Figure 4: 26MHz at J425

- Check signal of 26MHz reference clock oscillator at J425 (see figure below).
 If signal is not measurable (at least as a short pulse) but 26MHz sinewave at B600 is ok you have to exchange Mjoelner N600.

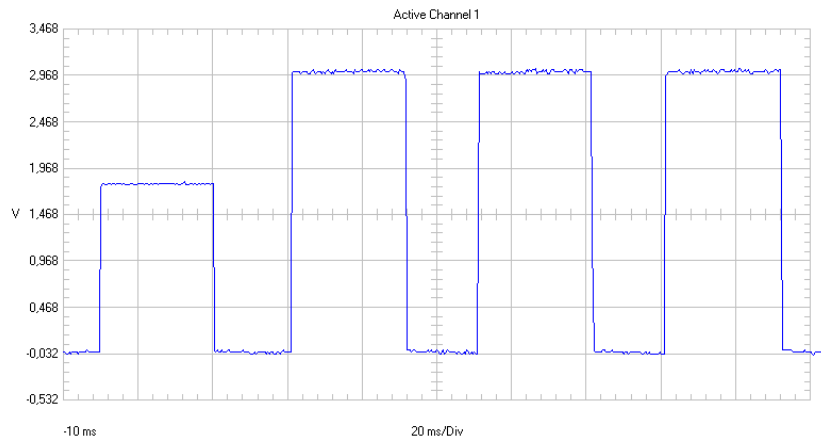
Figure 7: VSIM

- If fault persists and mechanical appearance of SIM reader seems to be ok, check with oscilloscope if SIM lines at SIM reader pins 1-4 are pulses to 1.8V / 3V as shown in the chart below (Phone switched on without SIM card). Signals are slightly different between pins 1-4 but the amplitude always is 1.8V / 3V.

In case that the above mentioned signal is not measurable at one or more SIM lines, check SIM lines for shorts to ground. Resistance of SIM data- and VSIM line normally is > 200kOhm, resistance of SIM reset- and SIM clock line normally is about 4.5MOhm.

If resistance of any line is not ok check parts the SIM lines consists of (R386, C203, C381, C390).

In case resistance of all lines is ok but fault persists, EMI-filter R386 may have internal interruption.

Change part and retest the phone. It also is possible that UEM D200 or UPP D400 are responsible for this fault.

Swap the phone because these components are underfilled and not changeable.

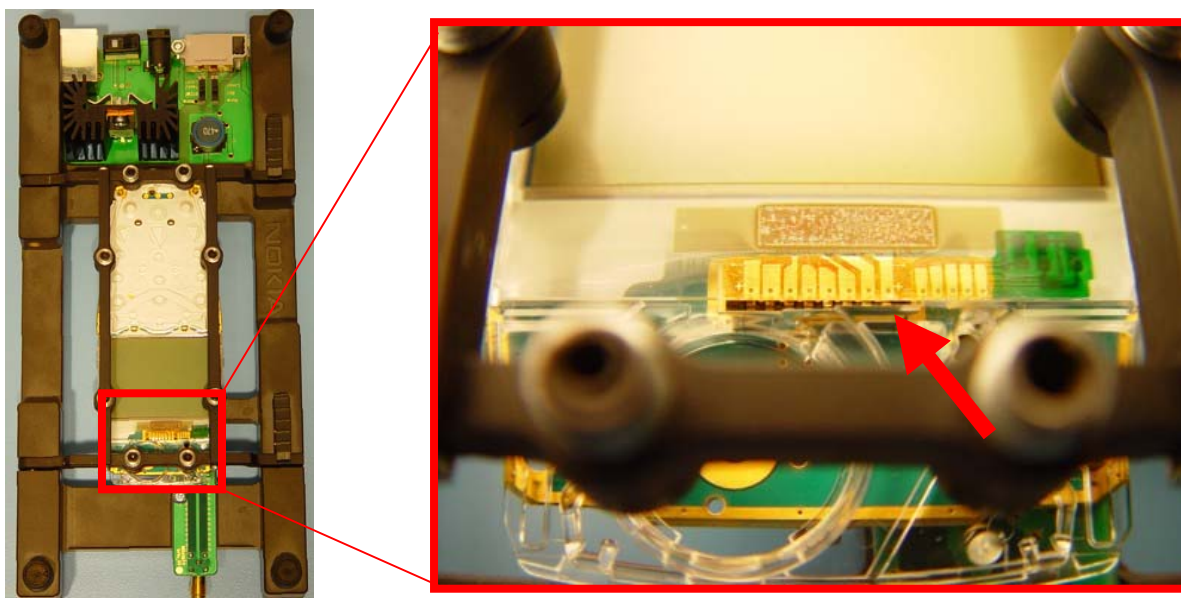
- Change display module I004 to check if it is responsible for the fault.
- If the fault persists check VIO 1.8VDC at C303, VFLASH1 2.8VDC at C304 and 10.65VDC at pin 8 from display modul, before measuring carefully remove display metal frame. After removing metal frame measure at the point shown in the right picture below, marked by the red arrow.
- If the display still does not work but the voltages are measurable, probably UPP (D400) is faulty. Swap the phone as UPP is not changeable.

Measure 10.65 VDC at the red arrow
