Repairhints

Service-Level 3 & 4

3510 / 3510i

NHM-8

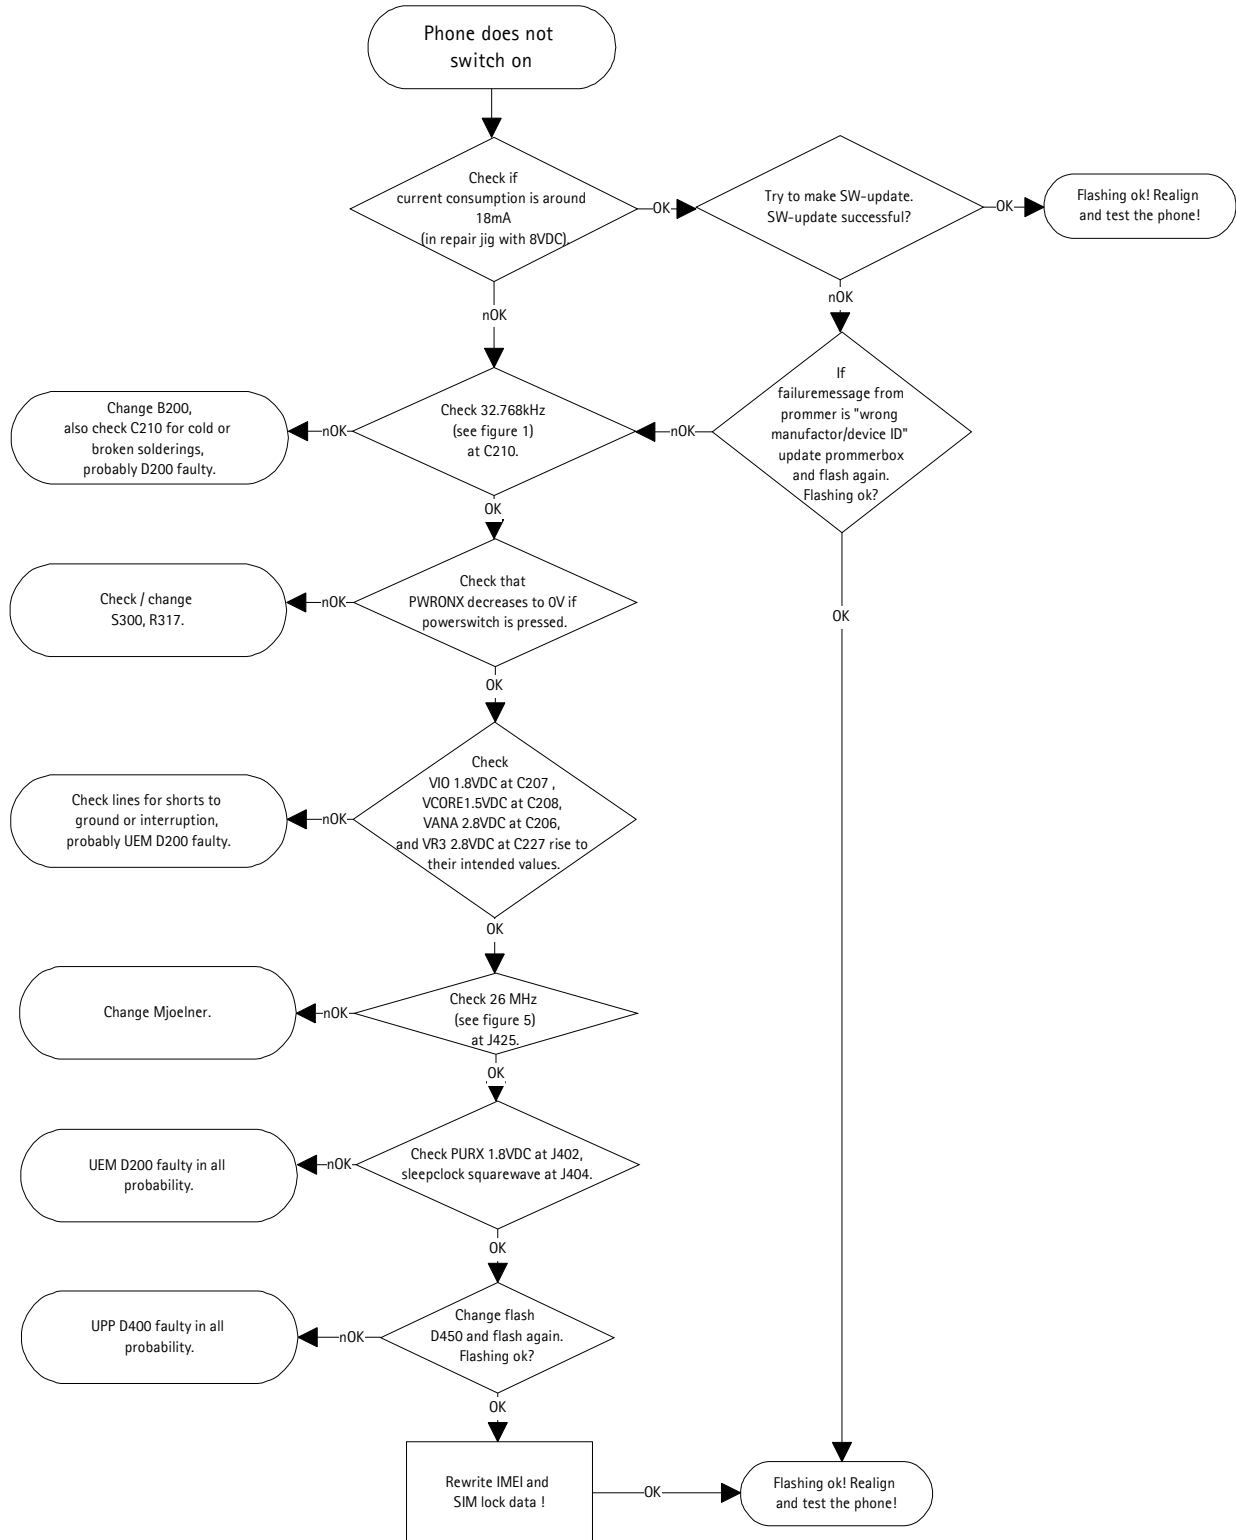
CHAPTER 3: Phone does not switch on

- Check mechanical appearance of battery connector; change part if it is bent, soiled or corroded.

- Check mechanical appearance of powerswitch; change part if necessary.
- Check voltage at S300: 4 VDC in case the switch is not pressed.
If voltage is not measurable or too low check especially R317 and C310.
- If switch is pressed, voltage at R317 (measure to UEM side) must decrease to 0V; otherwise you have to exchange the switch

- Check DC-voltages at C209 (0.59V) and C210 (0.42V). If voltages are not ok check lines for shorts to ground. It also is possible that UEM D200 is defect.
- Change the crystal B200 if DC-voltages at C209 / C210 are ok but no 32.768kHz sinewave signal is measurable (see picture below).
Note that this signal is always measurable in MJS-37 jig even though the phone is switched off.

- Check VR3 2.8VDC at C620.
- Check 26MHz sinewave signal at B600 (picture below). If it is not measurable check DC-voltage at both sides of crystal B600 that normally is 2VDC. In case that DC-voltage is missing Mjoelner N600 has to be changed. If voltage at crystal is ok but no 26MHz sinewave is measurable crystal B600 has to be exchanged.

- Check if current consumption remains on 18mA (in repair jig supplied with 8VDC). This indicates that Flash D450 probably is empty. Try to make SW-update. If any failure message appears during flashing, try SW-update a second time. A failure message C101 or C102 from prommer box indicates that D200 or D400 is defect in all probability. In case of failure message C586 the problem may be solved by changing the Flash D450.

- check 32.768kHz sinewave at C209/210
 - check VANA 2.8VDC at C206
 - check VIO 1.8VDC at C207
 - check VCORE 1.5VDC at C208
 - check VR3 2.8VDC at C227 (at least a short pulse!)
 - check PURX 1.8VDC at J403
 - if one value is not measurable or too low, check the corresponding line for short circuit to ground. If resistance of line seems to be ok UEM D200 is faulty in all probability - swap the phone as UEM is not changeable.
- If all above mentioned signals are ok try to flash the phone. A failure message C101 or C102 from prommer box indicates that D200 or D400 is defect in all probability. In case of failure message C586 the problem may be solved by changing the Flash D450.

- VIO 1.8VDC at C400
- VCORE 1.5VDC at C451
- SLEEPCLK 32kHz at J404
- 26MHz system clock at J425
- PURX 1.8VDC at J403
- If one of the above mentioned signals is not measurable probably UEM is faulty; swap the phone as UEM is not changeable. The only exception is a missing system clock – in this case check B600 and N600.
- If signals are okay try to flash the phone A failure message C101 or C102 from prommer box indicates that D200 or D400 is defect in all probability. In case of failure message C586 the problem may be solved by changing the Flash D450.

- It has been observed that in several cases the power amplifier N700 was responsible for the mentioned fault. A good indicator for this is the current consumption: if N700 is defect the current often rises up to more than 0.5A directly after connecting the phone to the power supply. To ensure that the PA is responsible, remove L703. If the current is ok now, the PA is defect in all probability.

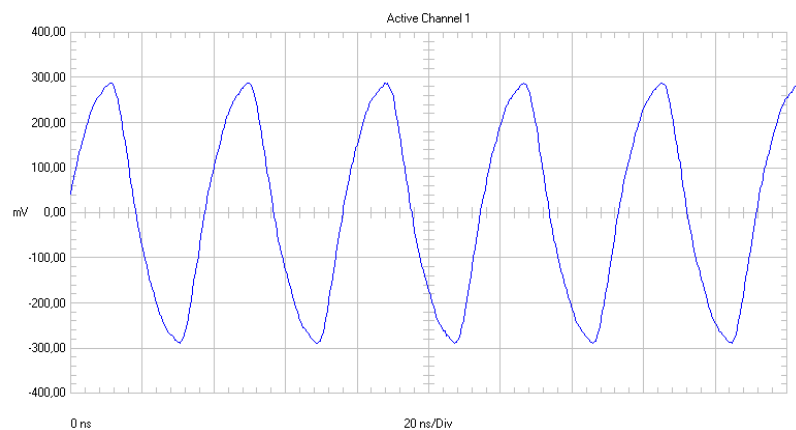
Figure 6: 26MHz at J425

- Check signal of 26MHz reference clock oscillator at J425 (see figure below).
 If signal is not measurable (at least as a short pulse) but 26MHz sinewave at B600 is ok you have to exchange Mjoelner N600.

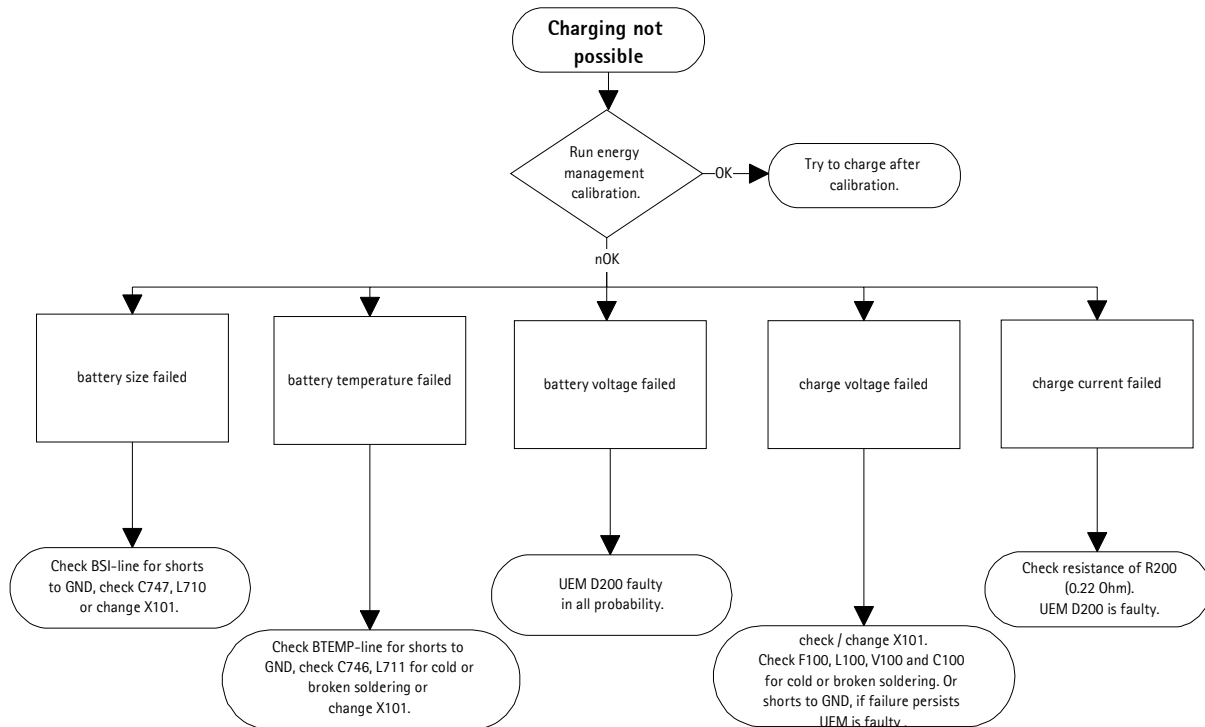
CHAPTER 5: Charging Faults

In case charging does not work permanently or charging is possible from time to time only, especially check spring contacts of bottom connector I007 and battery connector I010 if bent, soiled or corroded. Also make sure that contact pads for the connectors on the PCB are clean. If necessary clean the PCB with an appropriate amount of alcohol. Do not use any scratching or rubbing tools!

- Check mechanical appearance of battery connector and bottom connector; change parts if spring contacts are bent, soiled or corroded. Also ensure that contact pads for both connectors on the PCB are clean.

- Check resistance of fuse; must be zero Ohm.

- Check that V100 does not cause a short circuit to ground. Resistance of VCHAR-line to ground normally is 2.6kOhm.

- If all steps above are checked, probably UEM (D200) is faulty. Swap the phone because UEM is underfilled and therefore not changeable.

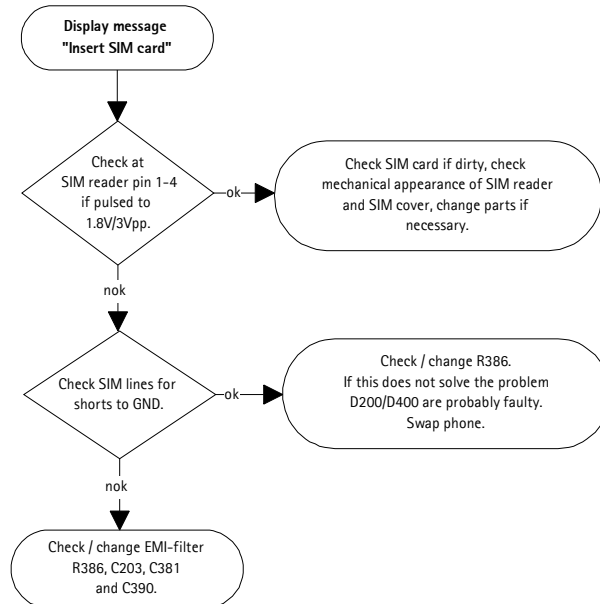
CHAPTER 6: SIM card faults

- If "Insert SIM card" appears on LCD, first of all check mechanical appearance of SIM card reader X387.
- You have to change SIM reader if contact springs are bent, soiled or corroded.

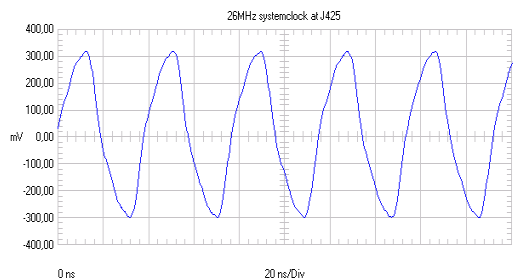
Figure 8: 26MHz at J425

- Check supply voltages VR1A 4.7VDC at both sides of R603, VR2 2.8VDC at C612, VR3 2.8VDC at C618, VR5 2.8VDC at C614, VR6 2.8VDC at C610, VR7 2.8VDC at C624, VIO 1.8VDC at C621 and VREF01 1.35VDC at C626.
- Check 26MHz reference clock at J425. Unfortunately it is not possible to check the signal of the SHF-oscillator directly, but you can check the control voltage at C641: if this voltage is outside its normal range (1.2VDC up to 3.2VDC) this indicates that the oscillator probably is faulty or the control loop is open. Further more check ResetX_Mjoelner at R604, which normally is 1.8VDC.

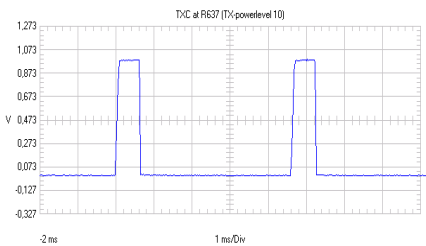
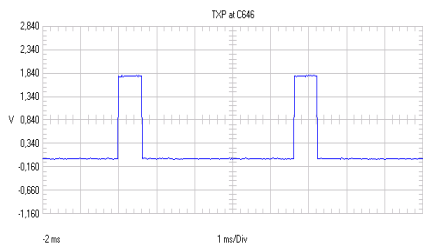
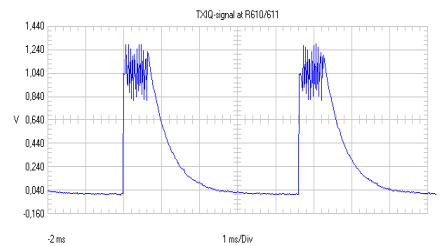
- Check with an oscilloscope TXC at R637 (0.7Vpp – 1.8Vpp depending on TX-powerlevel), TXP 1.8Vpp at C646 and TX/IQ-signals at both sides of C627/628:

If all these signals are ok but no TX-signal is measurable at L606 (L604 in GSM1800), Mjoelner N600 is faulty in all probability.

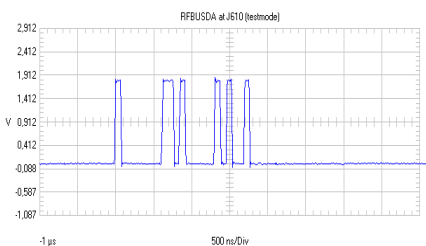
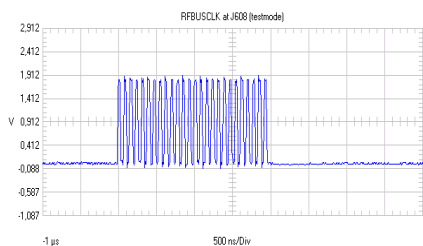
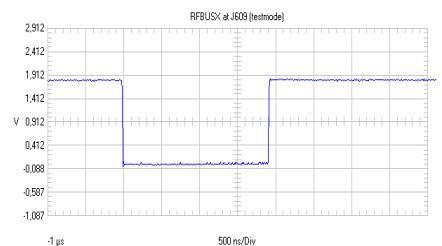
- Check with an oscilloscope RFBUSData at J610, RFBUSClk at J608 and RFBUSEnable at J609:

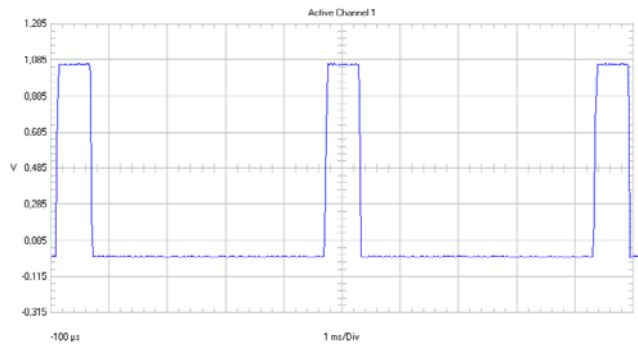
Figure 15: VPCTRL_G at R713

- Check VBATT 4VDC at both sides of L703
- Check VPCTRL_G 0.8Vpp – 1.4Vpp dependent on TX powerlevel at R713 (GSM 1800: VPCTRL_P at R708)

If the signal at the amplifier's input at R714 (GSM 1800: R711) and the above mentioned signals are ok but still there is no or too low TX power at the amplifier's output, it is necessary to exchange N700. Remember to perform RF-calibrations after having exchanged the power amplifier.

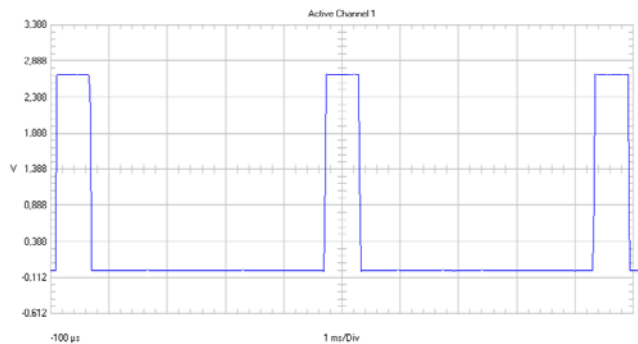
Figure 16: VTX_B_G at R717

- Check VTX_B_G 2.7Vpp at R717 (GSM 1800: VTX_B_P at R719)

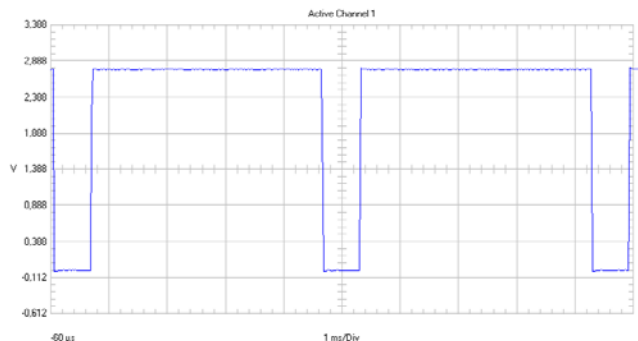
Figure 17: VTXLO_G at R716

- Check VTXLO_G 2.7Vpp squarewave in GSM 900 TX powerlevel 5 Et 6 at R716. If TX powerlevel is 7 or lower signal at R716 is 2.7VDC. (For GSM 1800 switching between high/low mode is not available)
